INTERIM MEASURES COMPLETION REPORT

**McDonnell Douglas Aerospace
U.S. EPA I.D. No. MOD000818963
Tract I Facility
Hazelwood, Missouri**

**Heritage Environmental Services, Inc.
Chicago Division
15330 Canal Bank Road
Lemont, Illinois 60439**

December 18, 1997

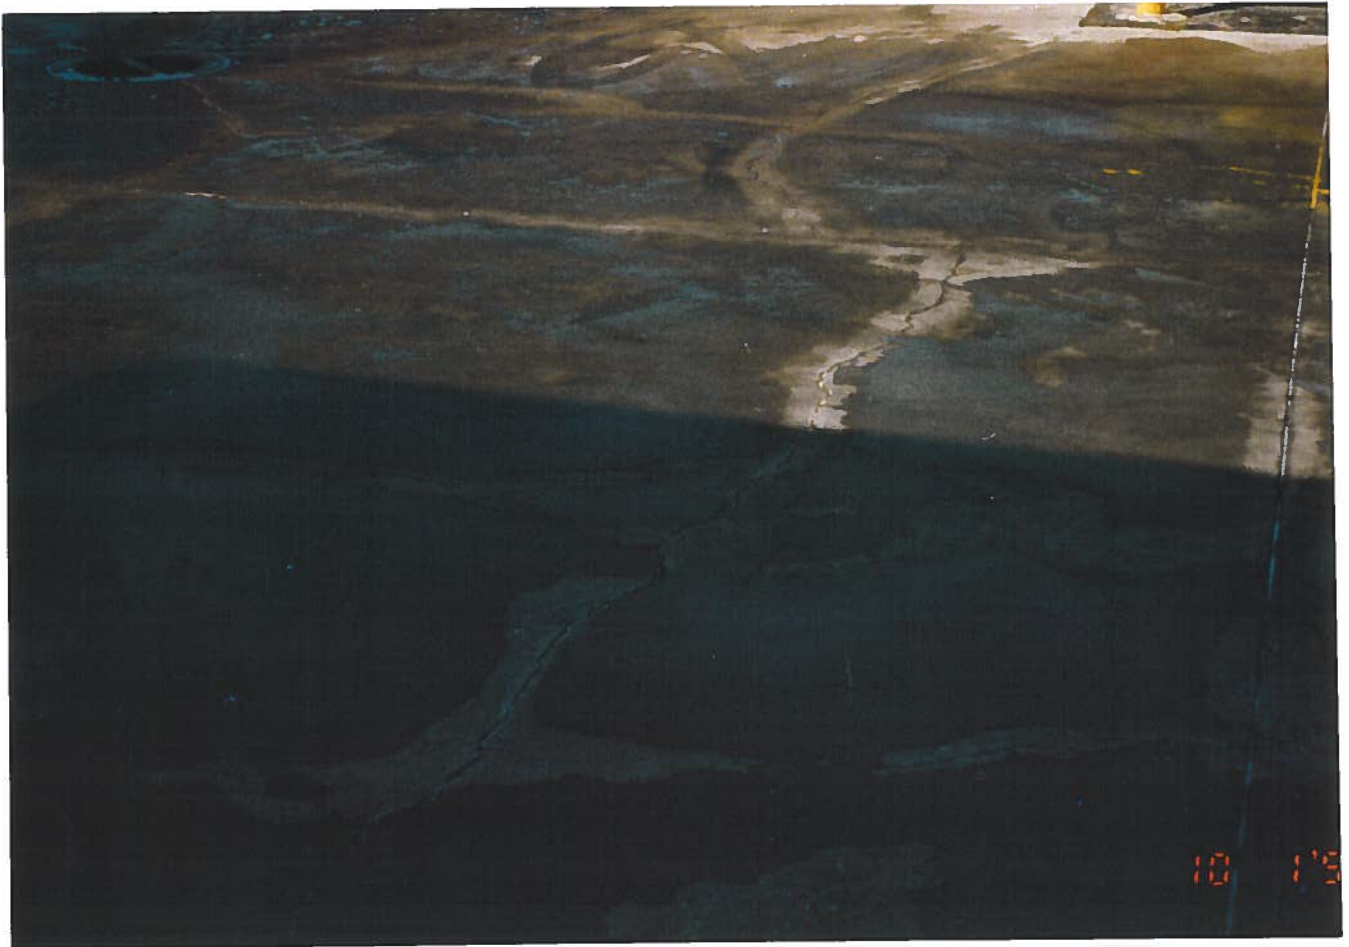
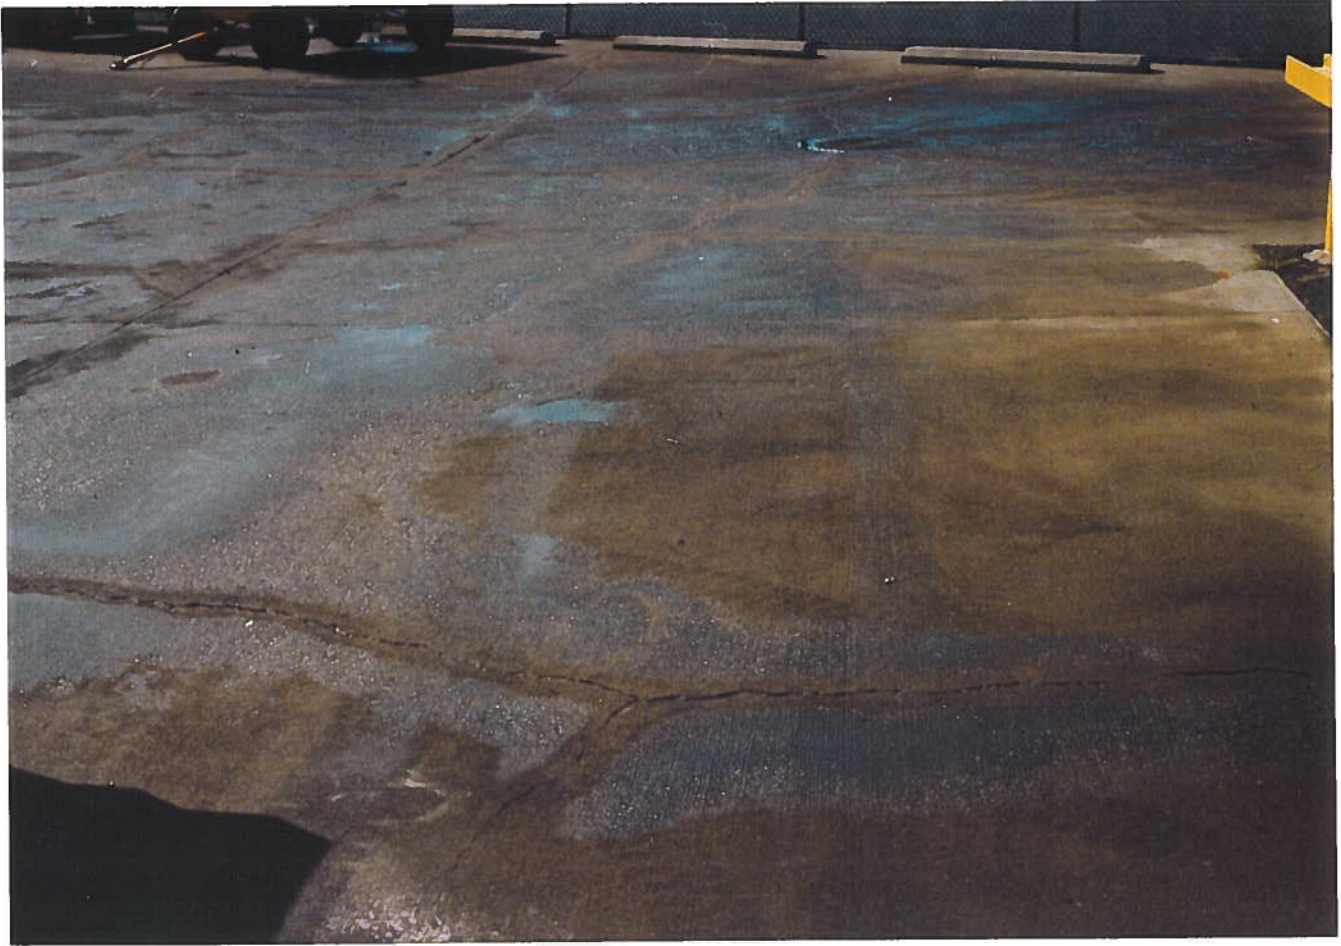
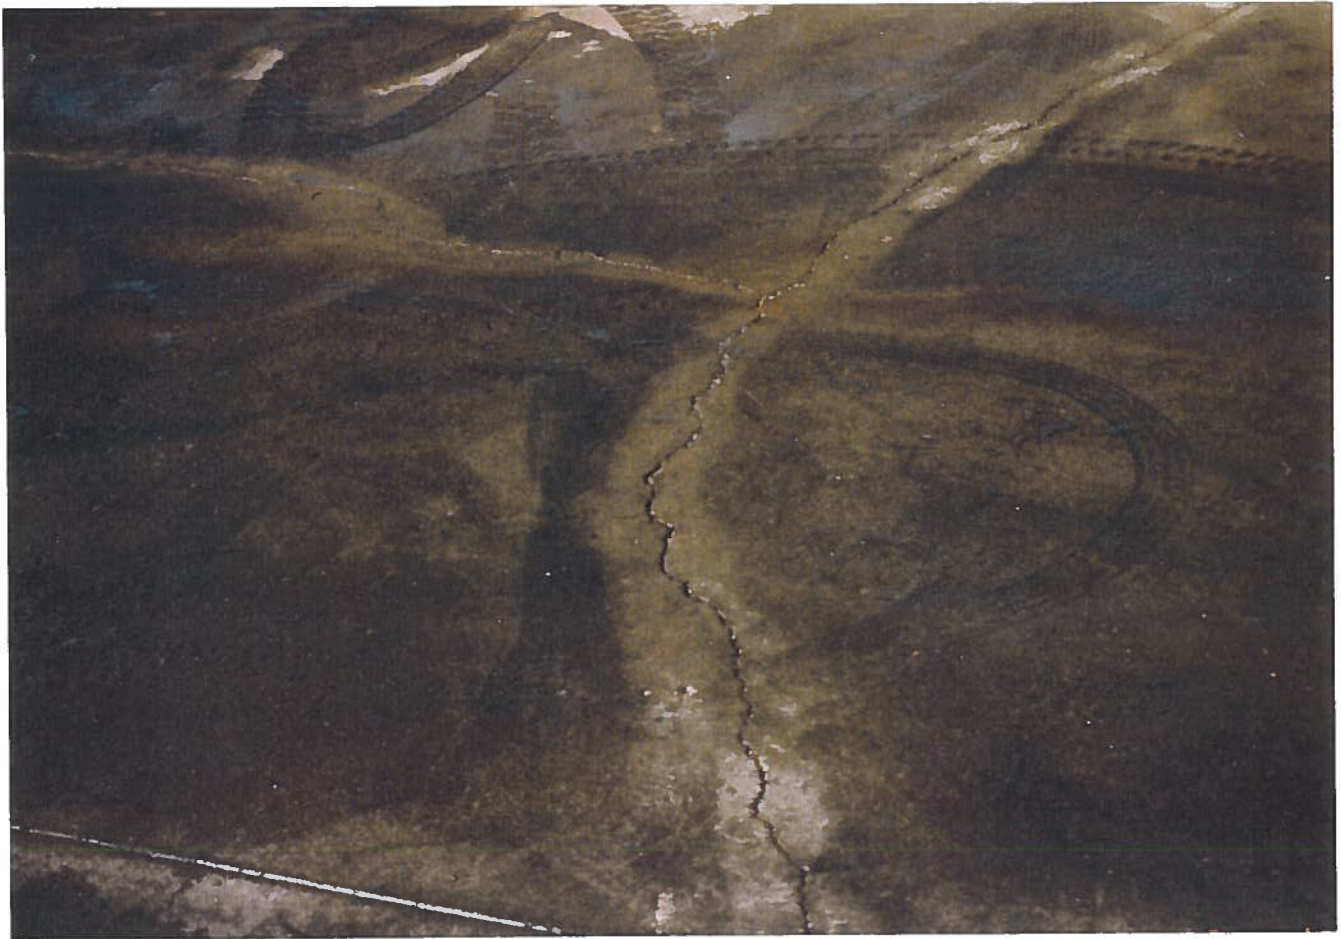
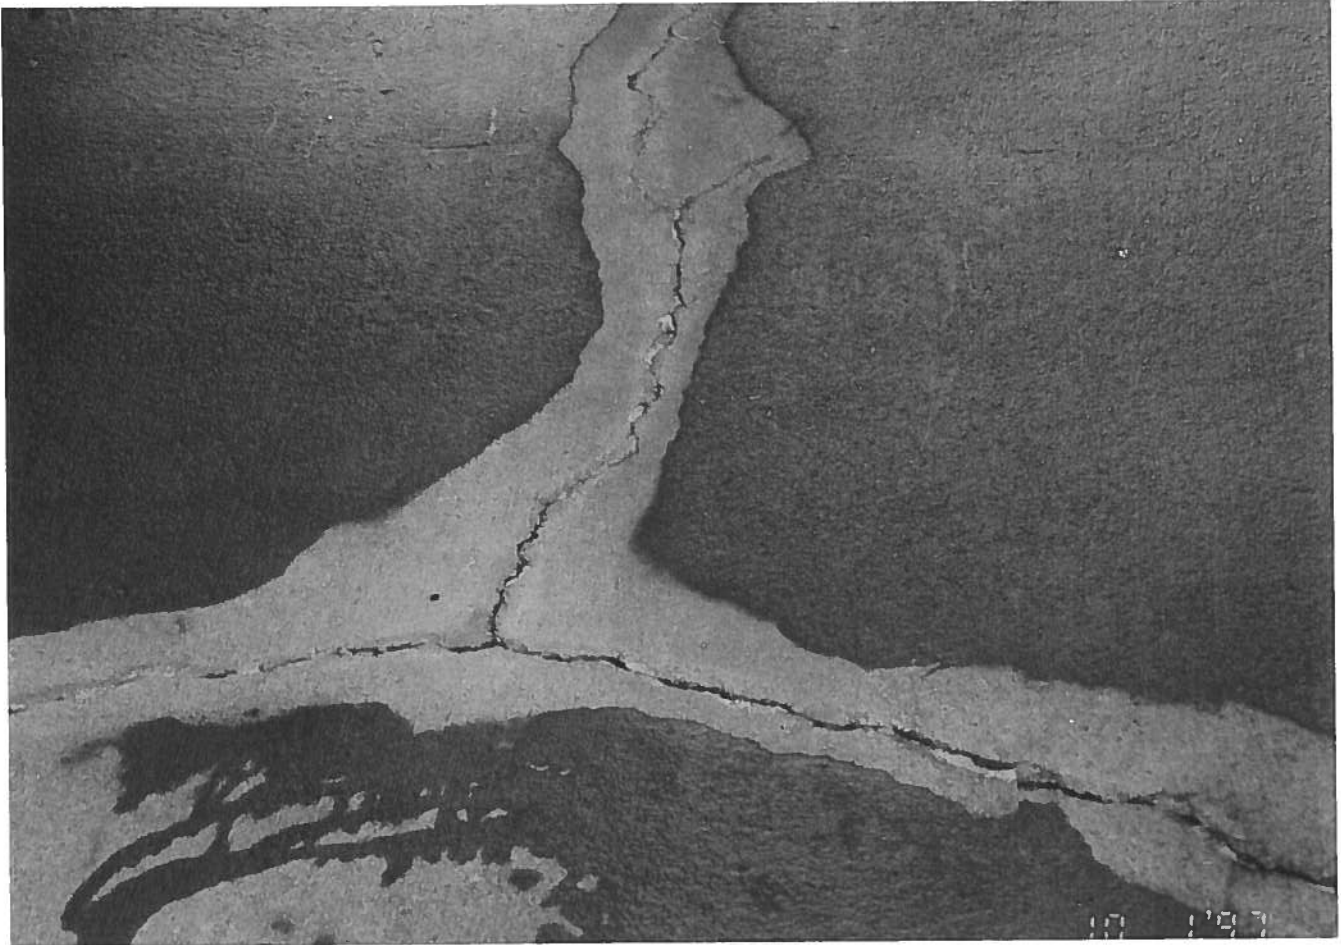
PHOTOGRAPH 18 (ABOVE): View of surface cracks in concrete surface at SWMU #26 after cleaning and prior to sealing.

Upon completion of the cleaning activities, the cracks were sealed utilizing a concrete-caulk sealant. Photographs showing the stages of cleanup and crack sealing are shown in Appendix 1, Photographs 16 through 25.

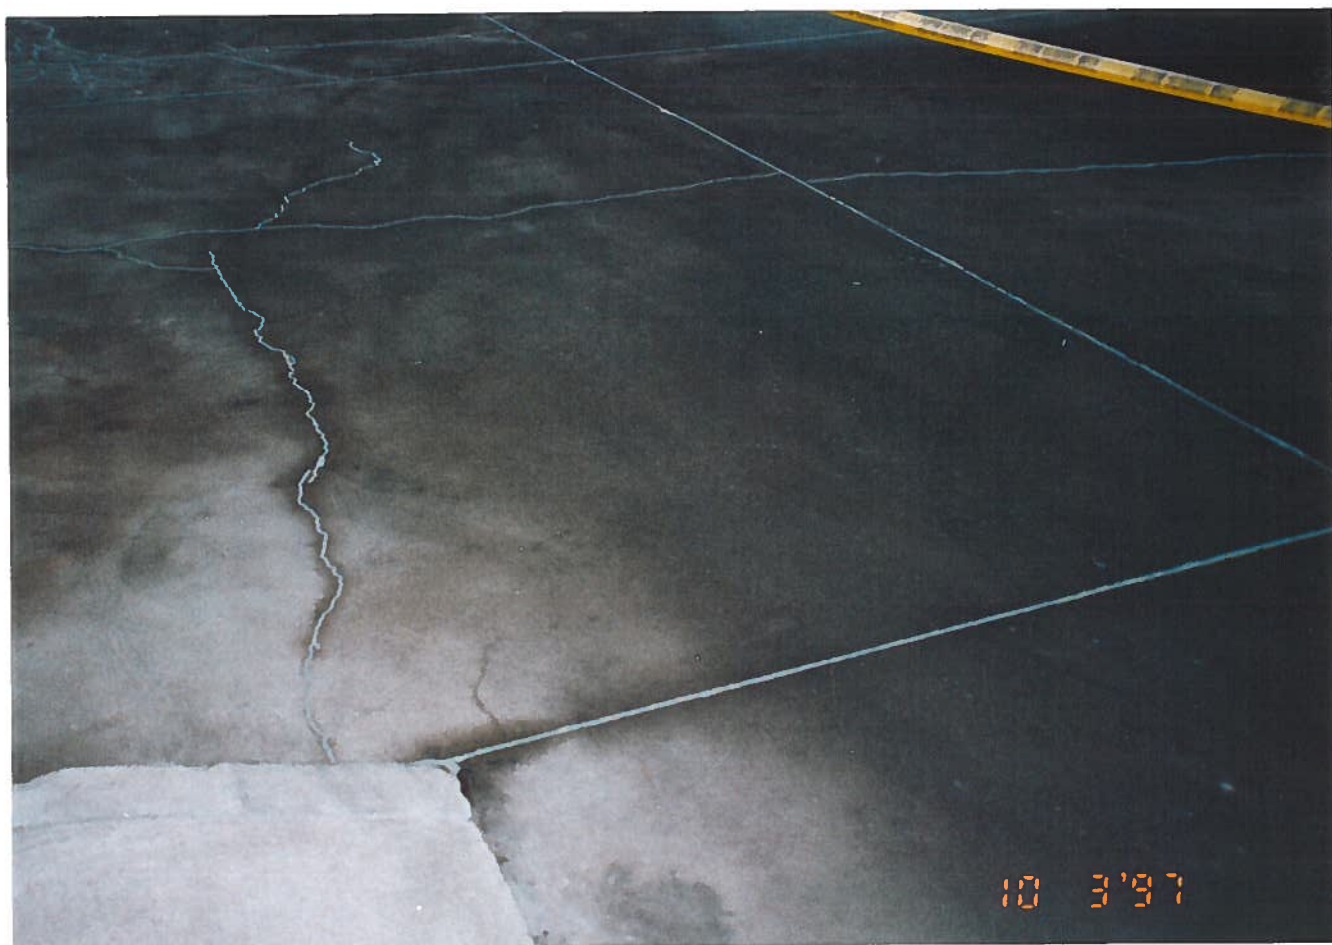
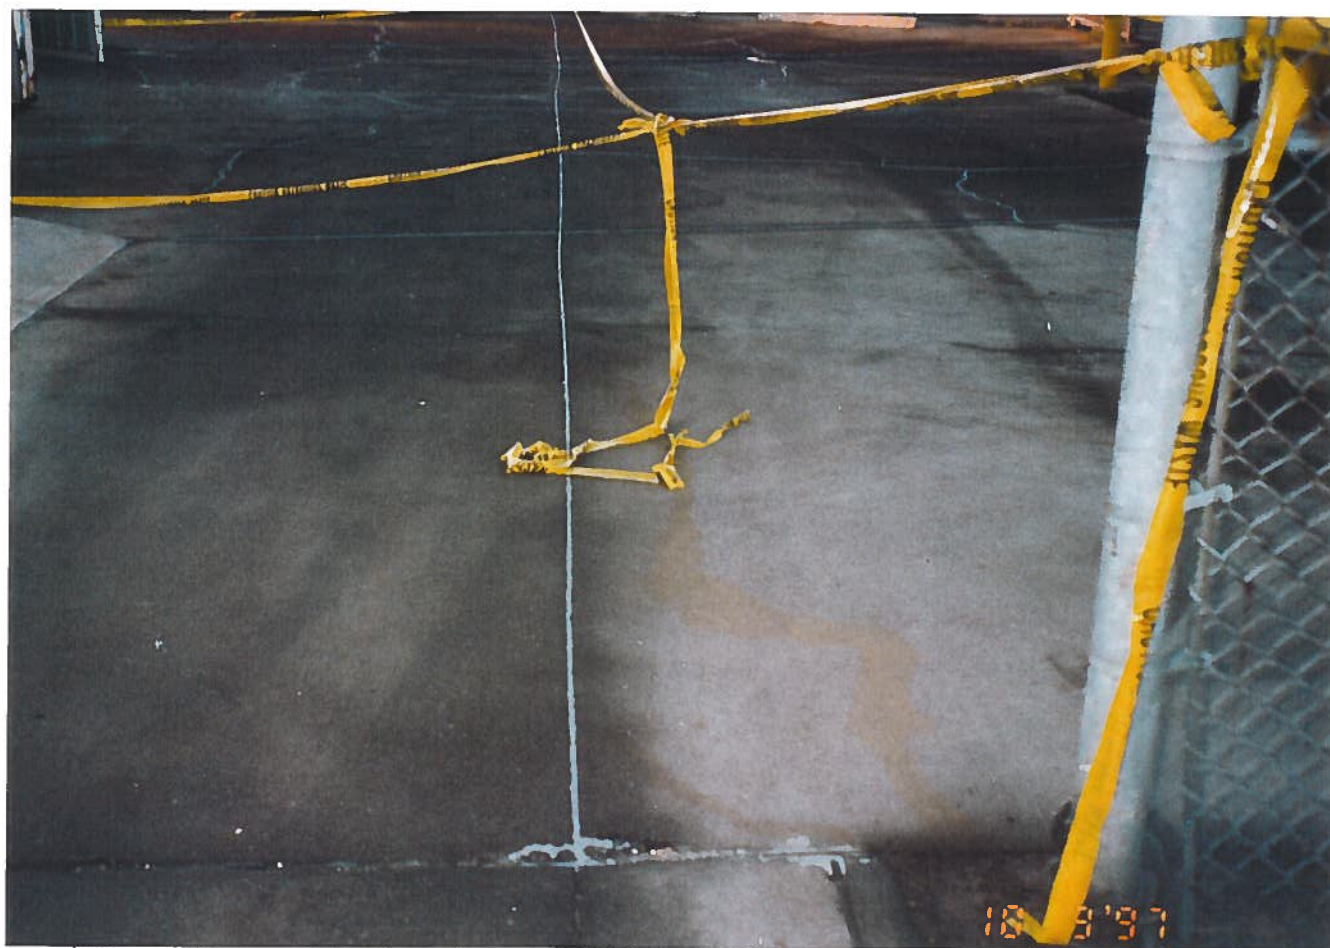
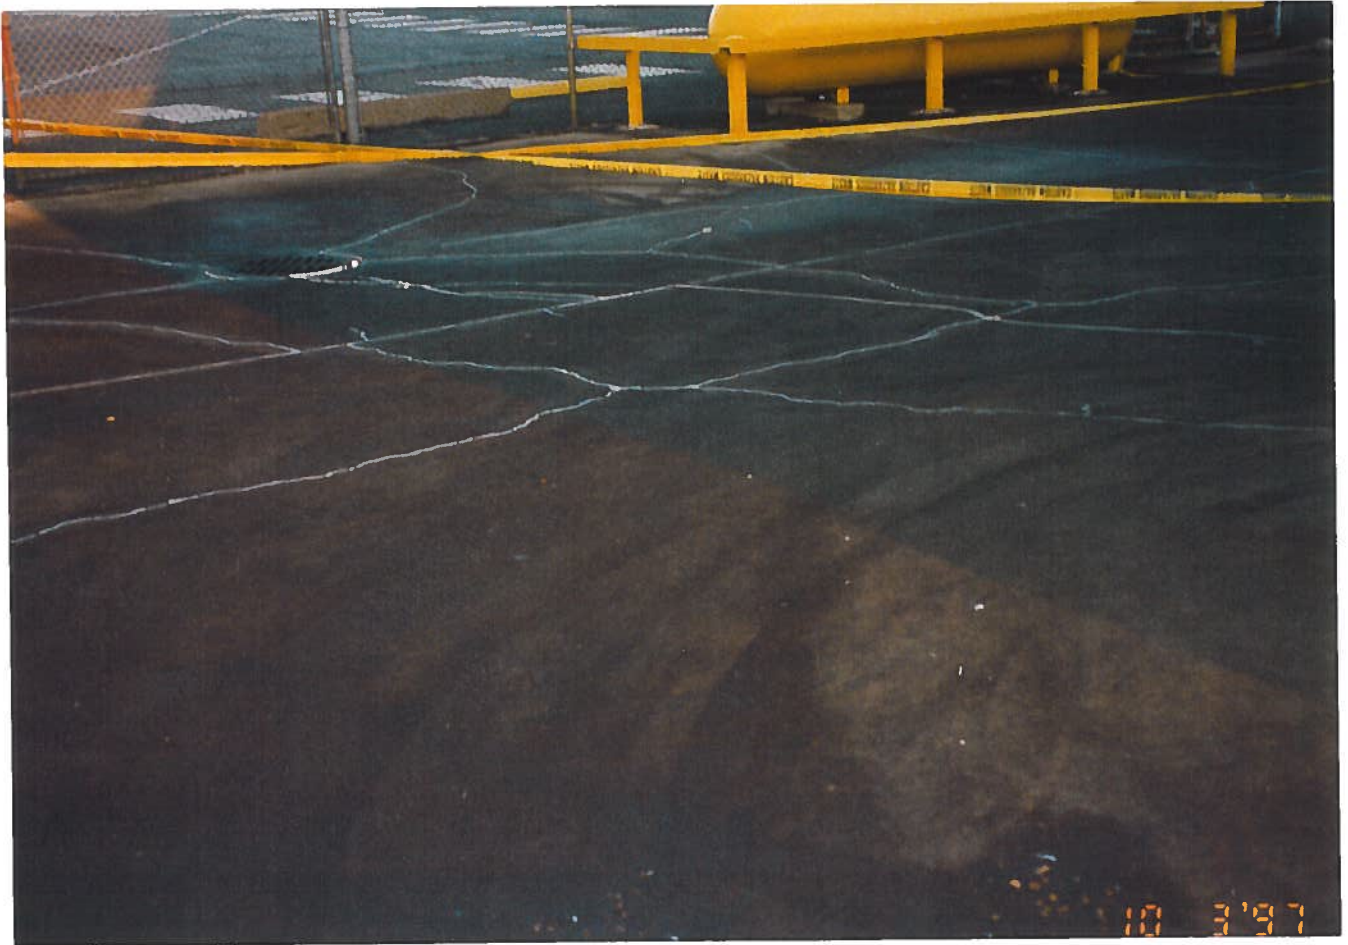
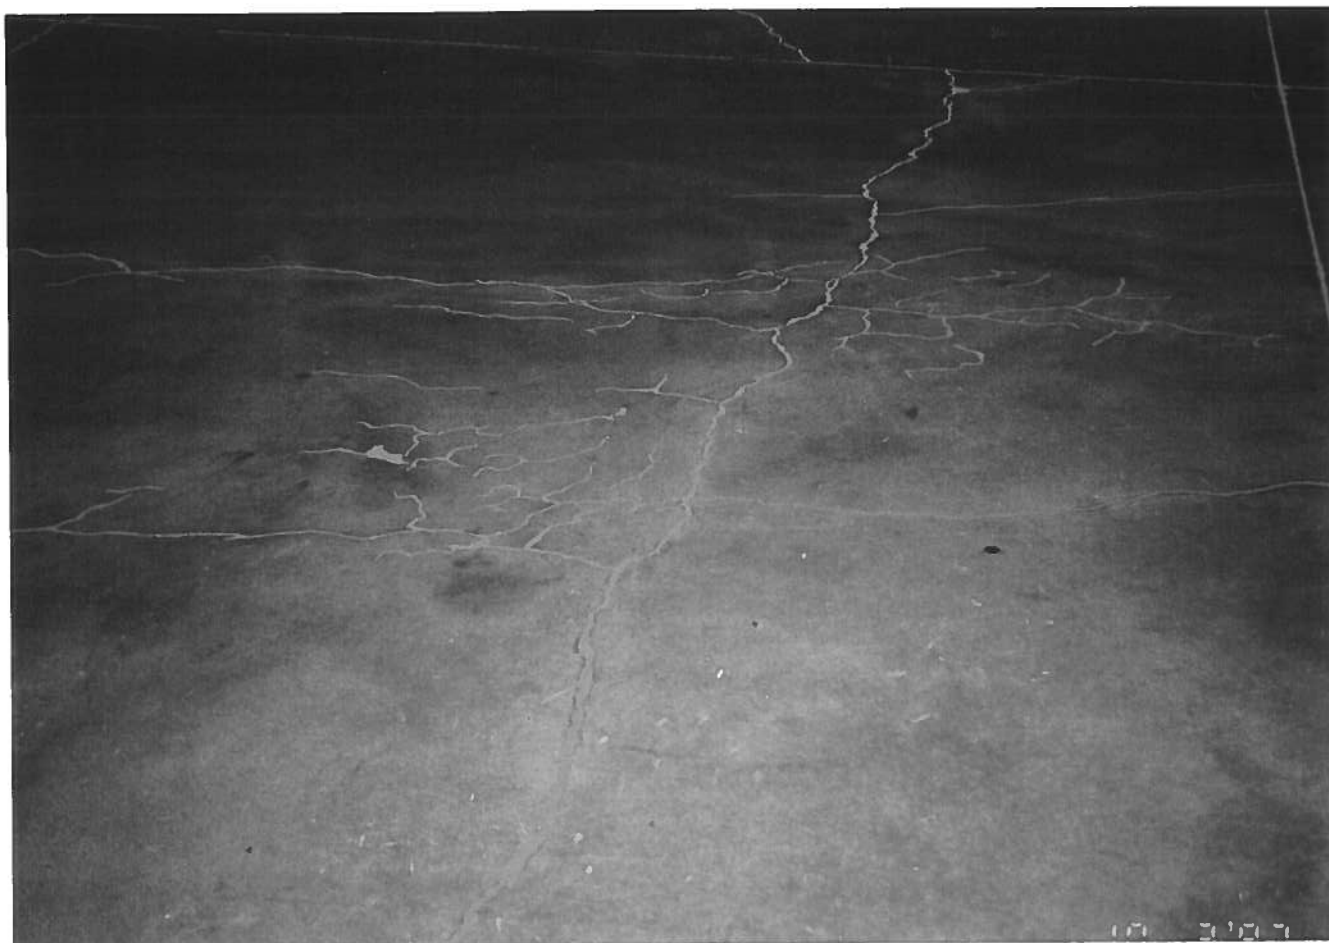
PHOTOGRAPH 22 (ABOVE): View of sealed cracks at SWMU #26.

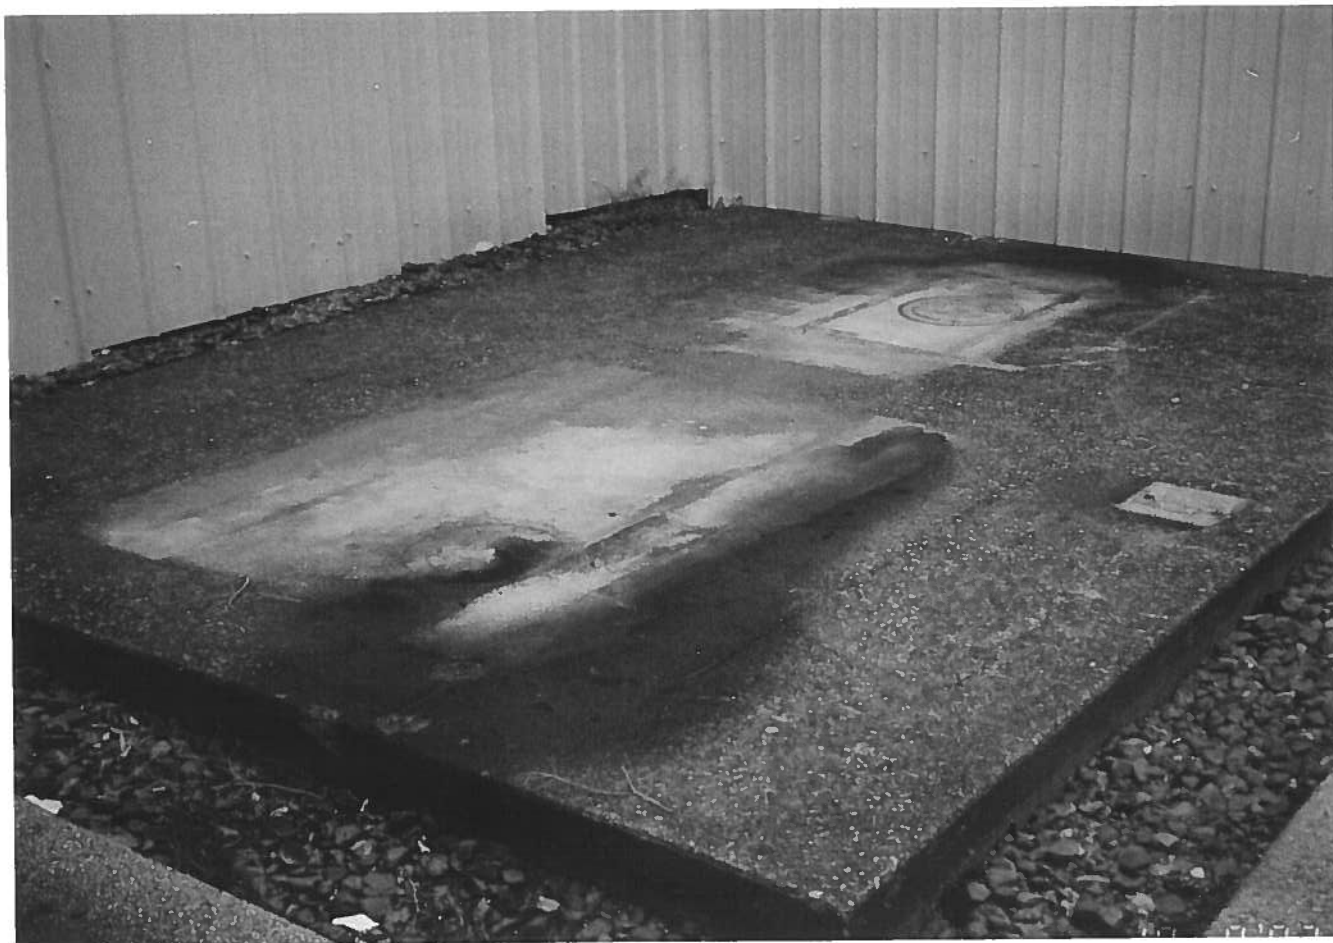
Specific concerns for this SWMU were the potential for transformer oil, containing PCB's, to impact underlying soil and groundwater. This concern was a result of apparent leakage of oil from the transformer as exhibited by oil stains on the concrete surface pad at the base of the former transformer. In addition, the oil stain at the west end of the concrete pad appeared to extend beyond the edge of the concrete pad and impact the surface gravel along the west perimeter of the concrete pad as shown in Appendix 1, Photograph 26. The oil stain at the east side of the concrete pad did appear to extend to the limit of the concrete pad but not extend beyond this perimeter as shown in Appendix 1, Photograph 28.

PHOTOGRAPH 26 (ABOVE): View of concrete pad for former power transformer at SWMU #28. Power transformer was removed for cleaning and disposal. View of concrete pad prior to cleaning activities. Note two stained areas left and right of photograph.

On October 7, 1997, the concrete pad was cleaned utilizing an enzyme-active cleaning solution designed for PCB removal from concrete and steel surfaces; Less-Than-10. The areas of the concrete pad exhibiting oil staining were soaked with the Less-Than-10 solution. After a sufficient saturation time, the surface stain was scrubbed with a stiff brush and the cleaning solution was vacuumed from the surface. This procedure of soaking, scrubbing, and vacuum removal was repeated until satisfactory results were obtained.

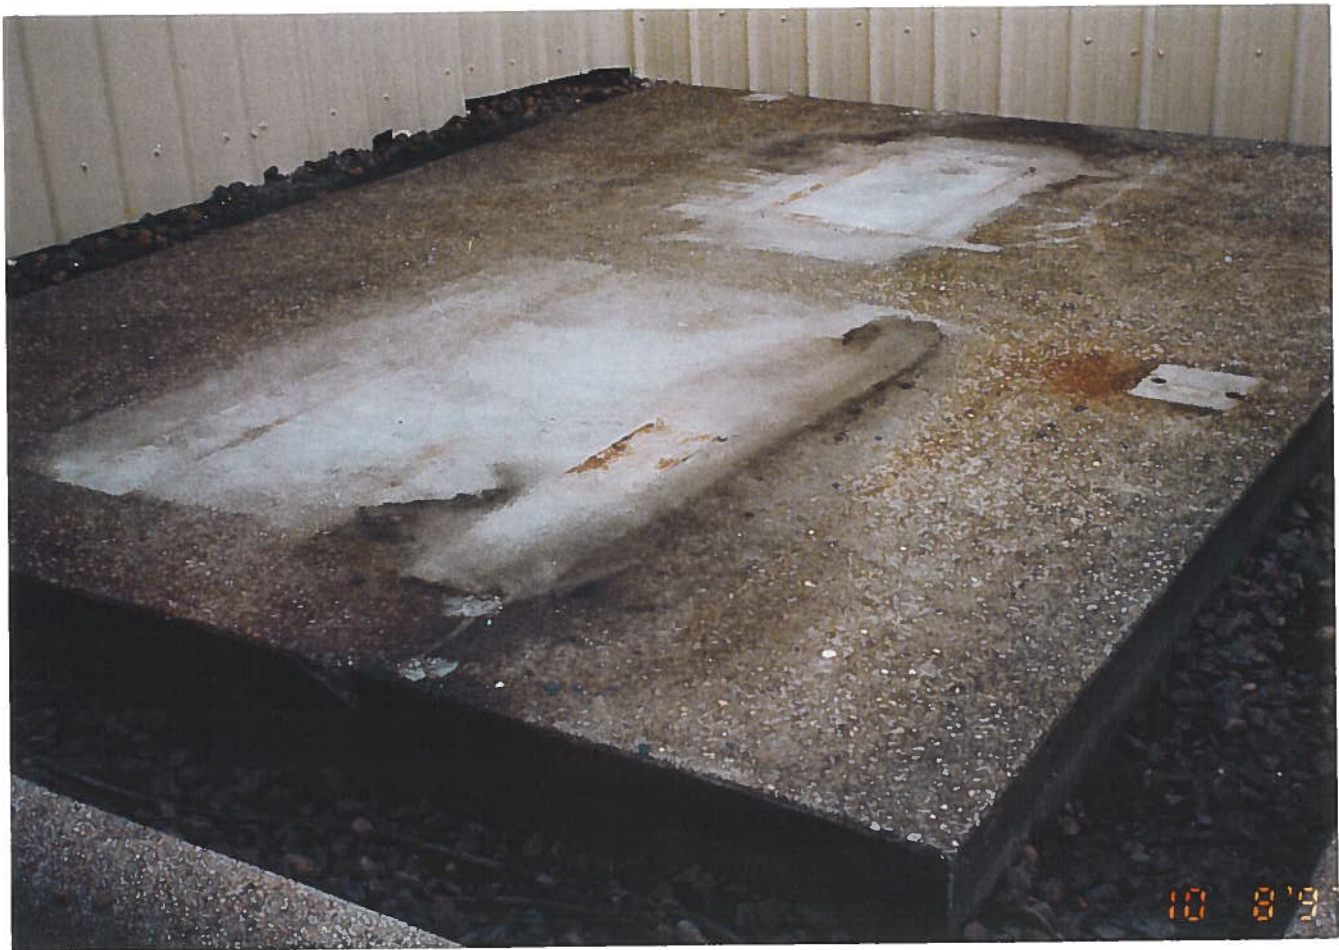
PHOTOGRAPH 27 (ABOVE): View of concrete pad at SWMU #28 after completion of pad cleaning activities.

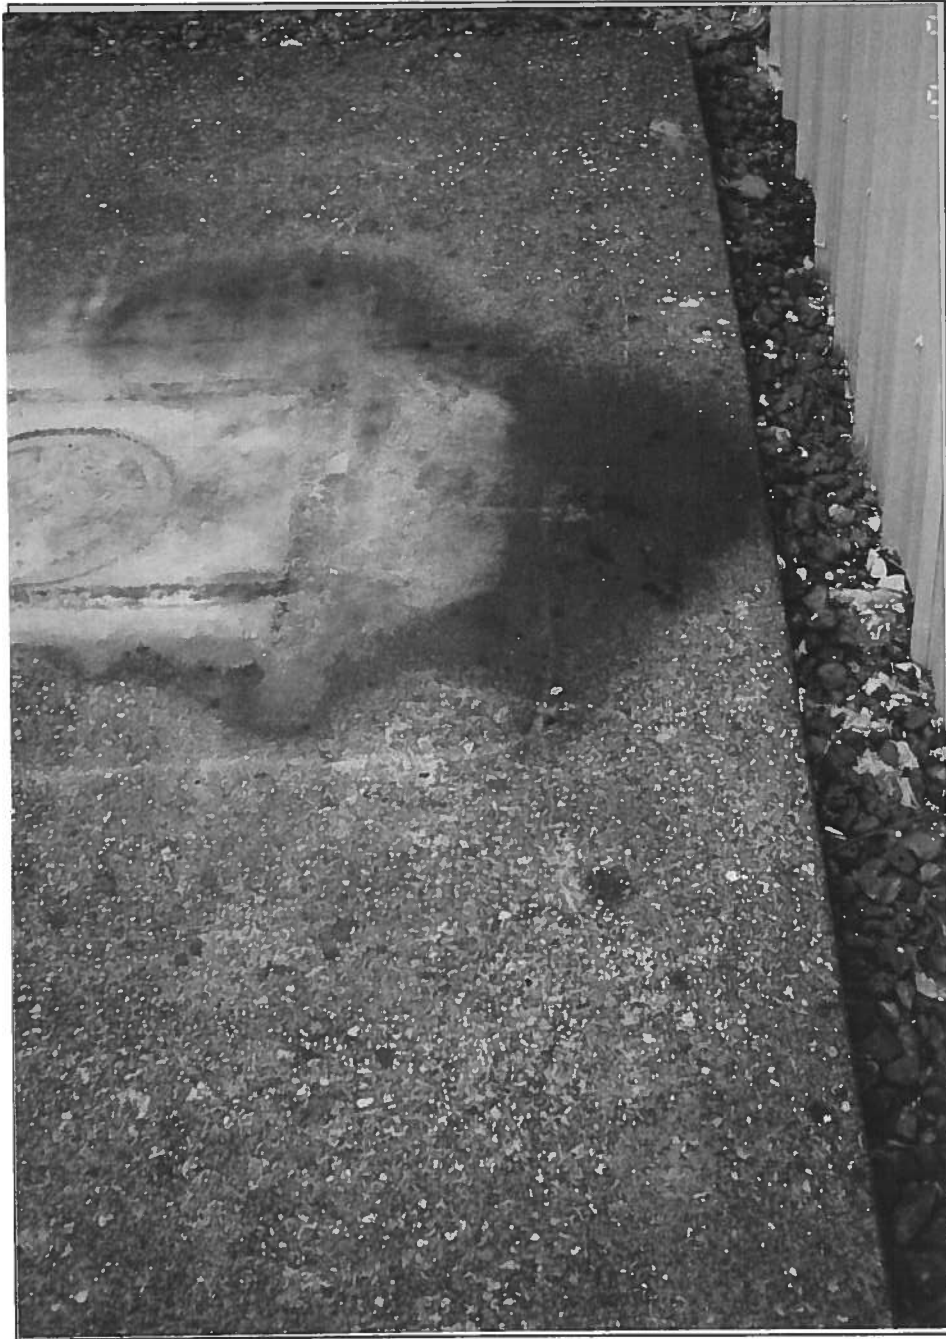
PHOTOGRAPH 28 (ABOVE): Close up view of right side of concrete pad at SWMU #28 prior to cleaning.

Gravel surrounding the west and south-west perimeter of the concrete, which visibly exhibited indications of oil-staining, was removed and containerized in a steel 55-gallon drum. Soil underlying the gravel surface did not exhibit a visible indication of oil-impact and as a result, soil was not excavated.

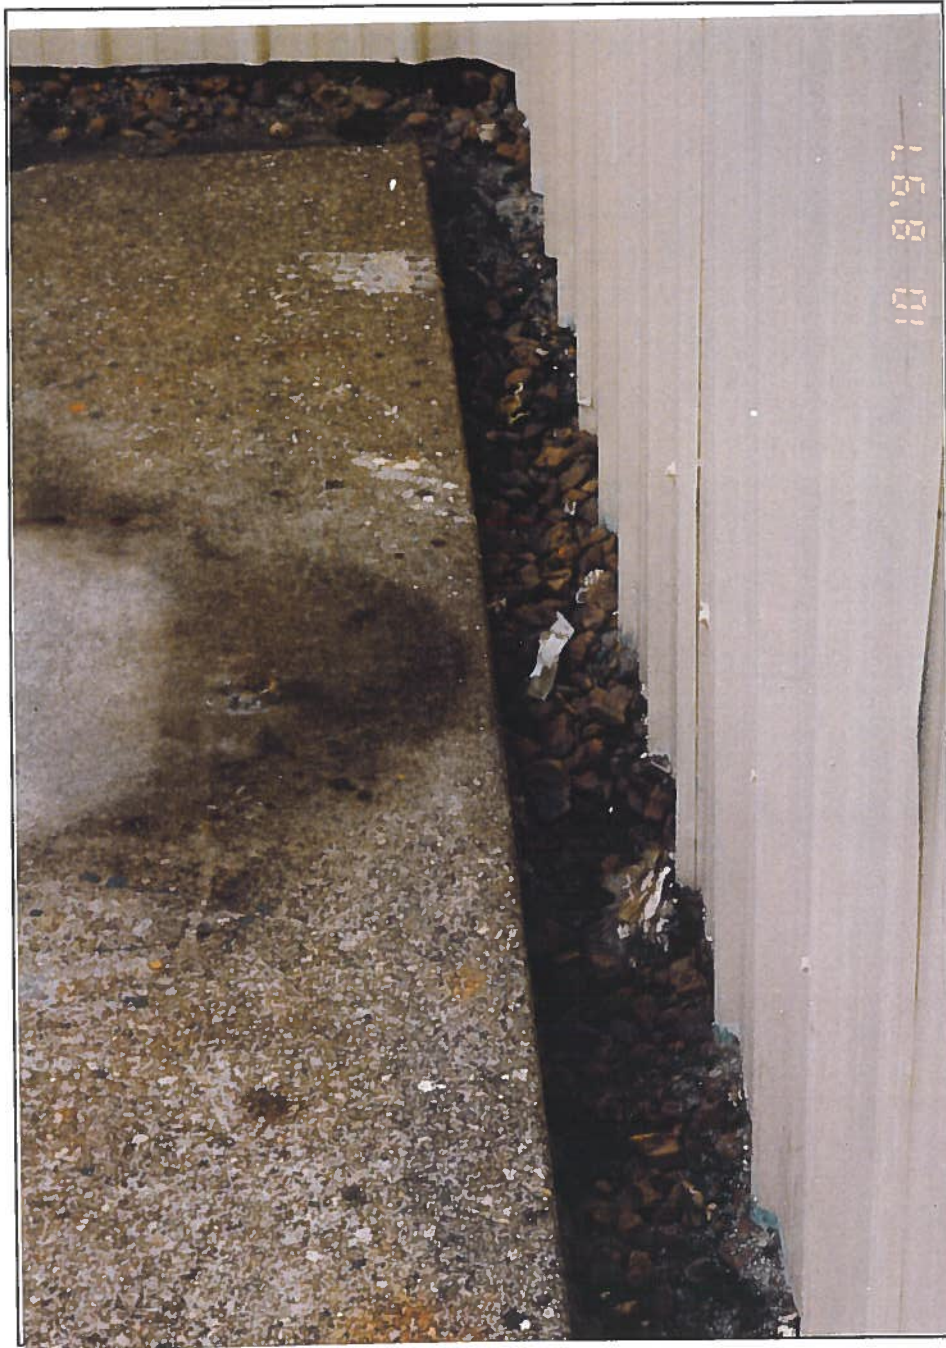
PHOTOGRAPH 29 (ABOVE): Close up view of right side of concrete pad at SWMU #28 after cleaning.

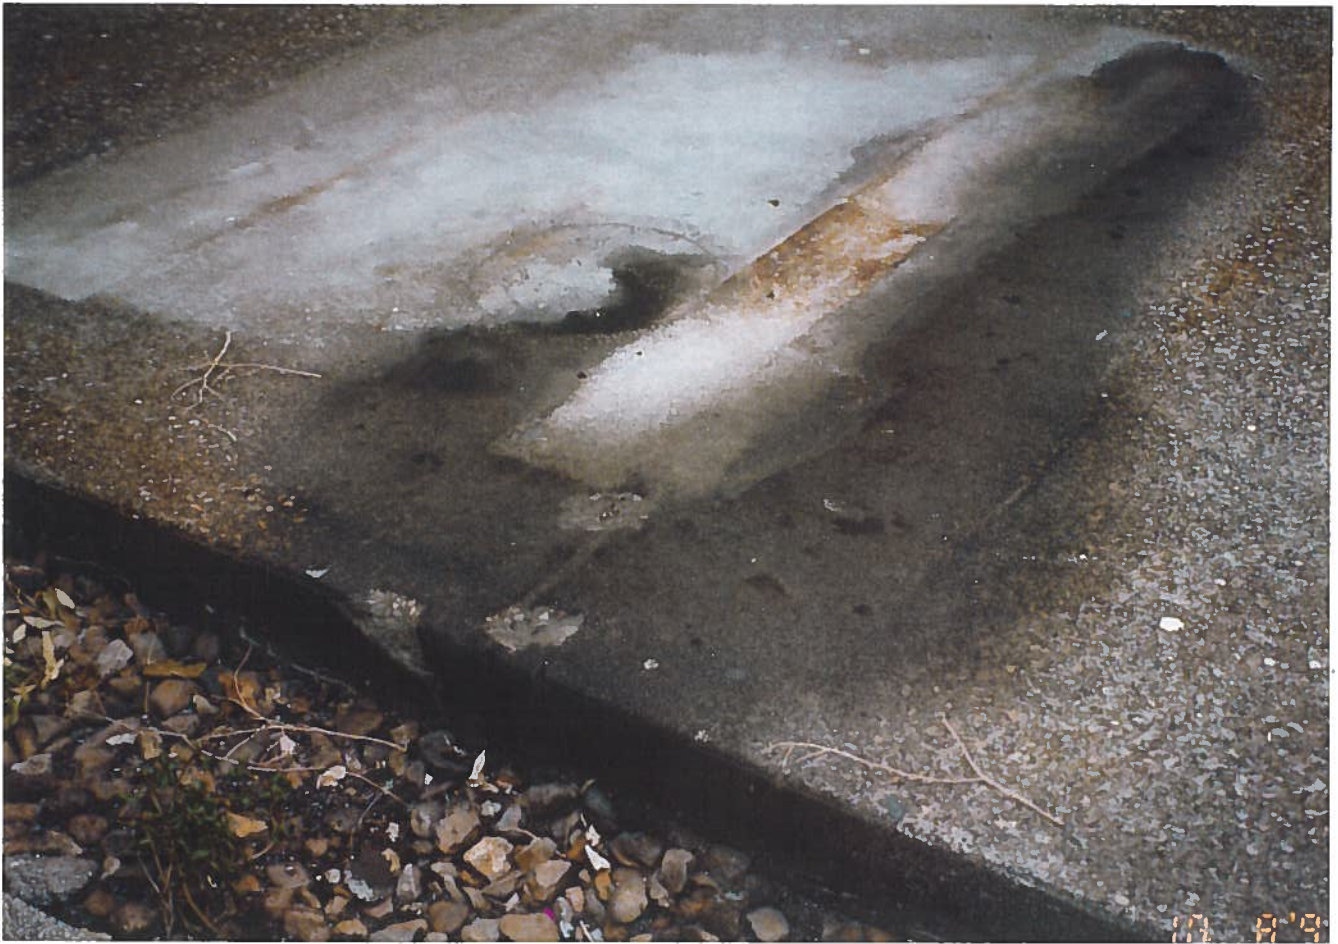
PHOTOGRAPH 30 (ABOVE): Close up view of concrete pad at SWMU #28 prior to cleaning.

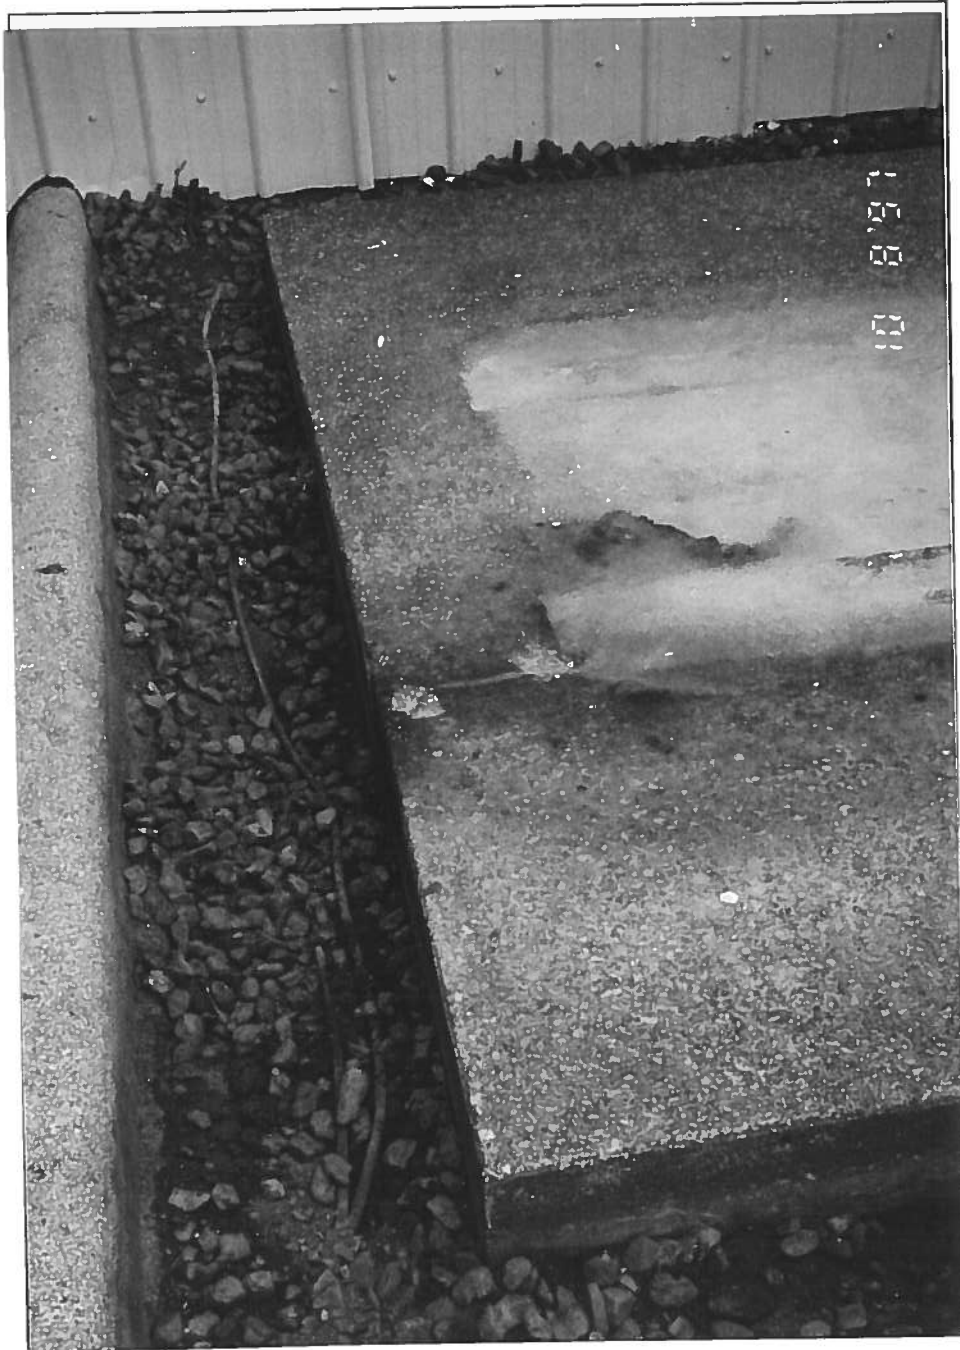
PHOTOGRAPH 31 (ABOVE): Close up view of concrete pad at SWMU #28 after cleaning.

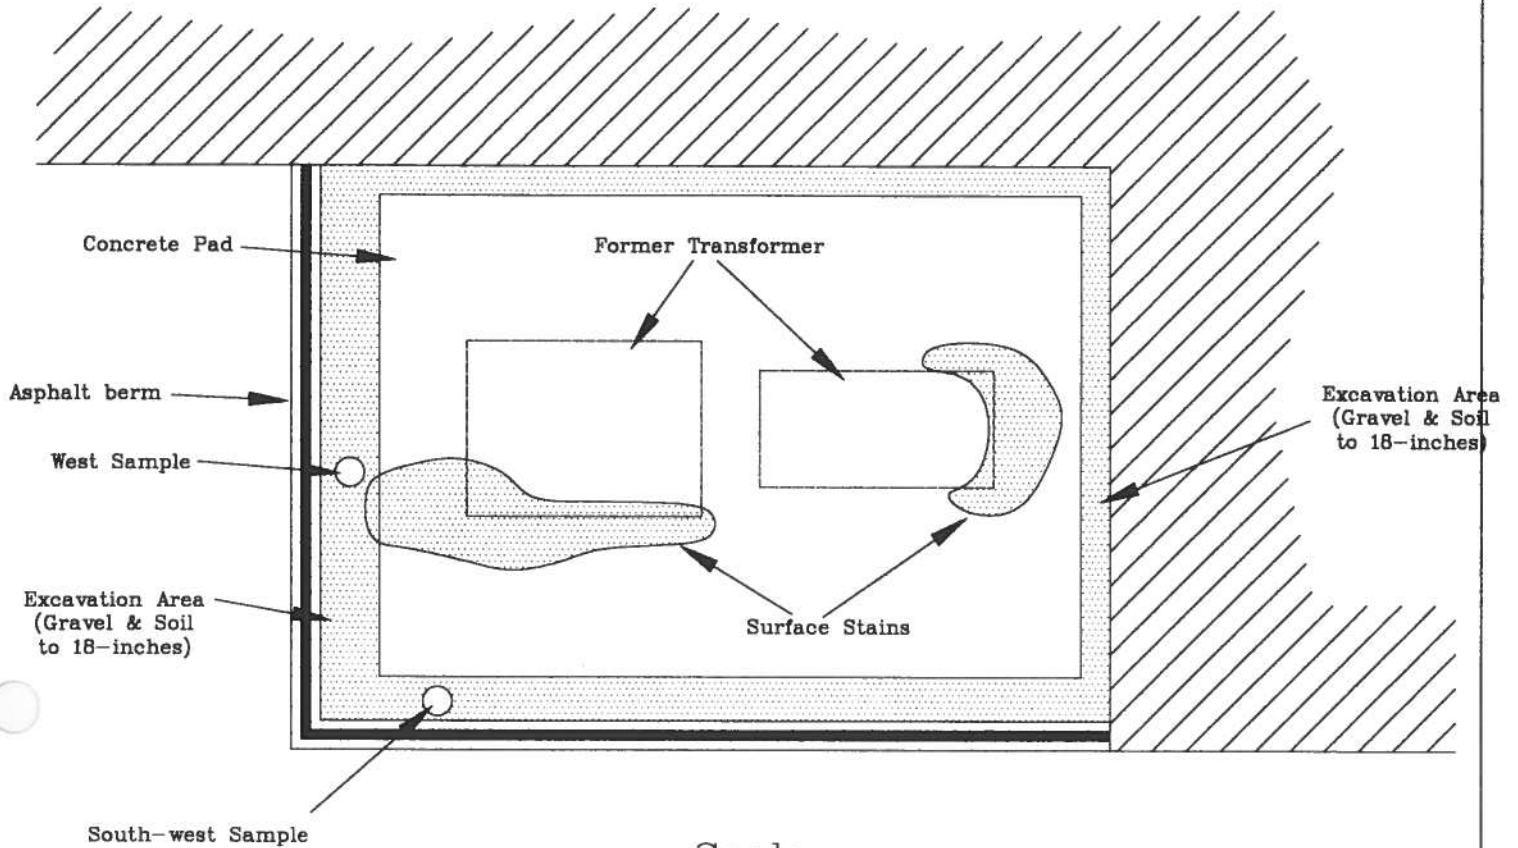
FIGURE 1

Since the laboratory result of 1.4 mg/kg PCB on the 10 to 12-inch composite sample exceeded the Missouri Department of Health any-use soil criteria of 0.65 mg/kg for PCBs, additional soil excavation activities were performed along the perimeter of the concrete pad. PCB impacted soil was excavated to a depth of 18-inches below surface grade and containerized in a steel 55-gallon drum. As a result of the laboratory analysis from the previously submitted soil samples, which indicated PCB constituents were not present above method detection limits at a depth 18-inches below surface grade, additional soil samples were not collected at the completion of the excavation activity. The location of the collected soil samples and limits of the excavation is shown in Figure 1, Appendix 3.
